MG/214

SERVICE MEMORANDUM

SLACKNESS IN STEERING COLUMN
UNIVERSAL JOINT

TWO-SEATER
SERIES 'MGA'

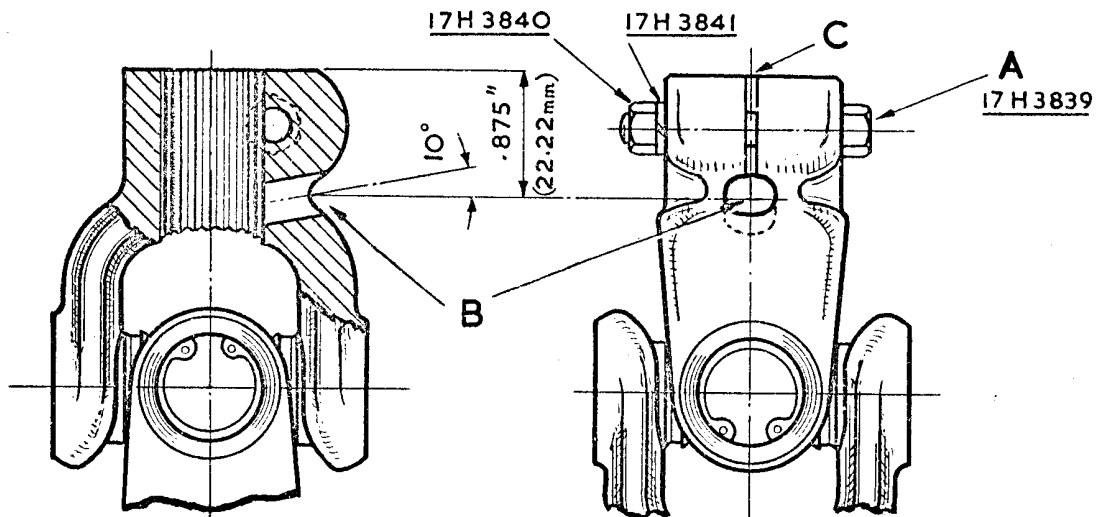
Considerable wear can only be dealt with by the fitting of a complete new assembly but a slight amount of slackness may overcome by increasing the nip of the bolt 'A'.

This is achieved by drilling a 5/16" (.313" or 7.94mm.) hole 'B' and lengthening slot 'C' to break into this hole as shown.

If bolt 'A' or its nut are damaged in any way, new ones should be fitted. These are of 45/55-ton material; the bolt is marked 'R' on the face of the head and the nut has an identification groove on the washer face.
