**SERVICE MEMORANDUM**

STEERING BALL SOCKET ASSEMBLY

'MGA' & 'MAGNETTE'

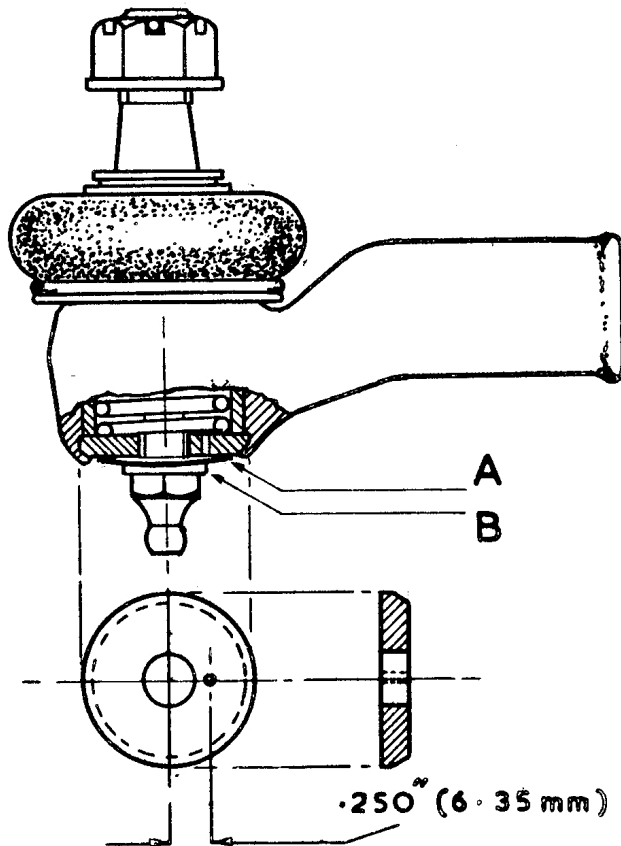
It is possible with high-pressure greasing apparatus to blow out or distort the washer at the base of the ball socket and a new form of ball socket was introduced at the under-mentioned car numbers to obviate this trouble:

Existing sockets can be modified by drilling a hole 1/16" diameter in the washer at the base of the socket and fitting a Belleville washer 'A' (Part No. ACH6170) and the special fibre washer 'B' (Part No. ACH6173), as shown in the sketch below.

It is most important to ensure that only the correct fibre washer (Part No. ACH6173) is fitted. An ordinary commercial fibre washer must not be used.
