MG/234

SERVICE MEMORANDUM

WATER LOSS

'MGA' TWIN-CAM

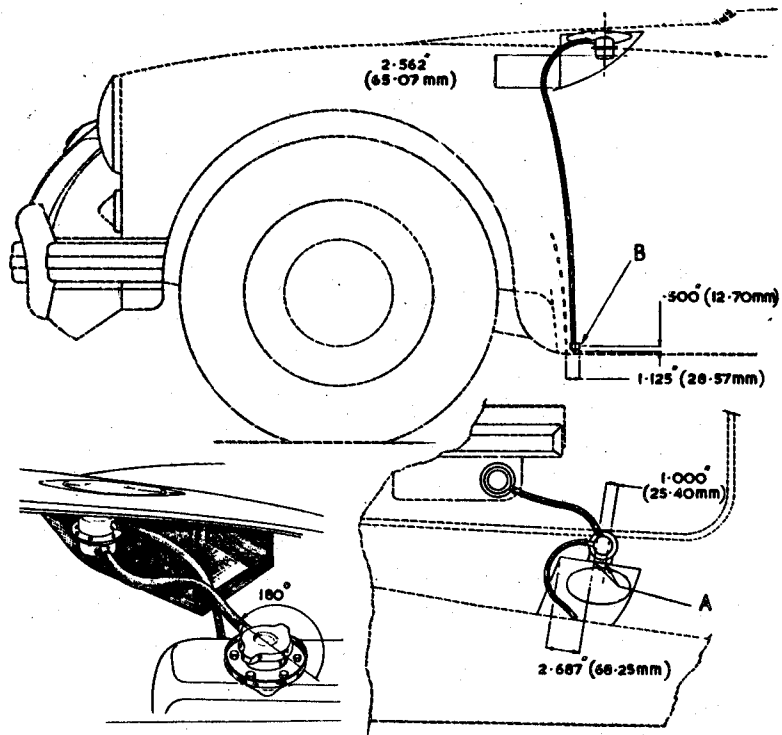
It has been found that this can occur owing to vibration of the valve in the header tank pressure cap.

Note that the filler neck on the header tank must be removed and rotated through 180° as shown in the sketch overleaf.

To mount the valve bracket, two 9/32" (7.14 mm.) holes must be drilled in the inner face of the air duct as shown at 'A'. A 7/32" (5.56 mm.) dia. hole must also be drilled in the body side panel for the overflow tube clip 'B'.
