SERVICE MEMORANDUM

MGF/26

JAMMING IN GEAR

MAGNETTE ZA & ZB
MAGNETTE Mark III
MGA

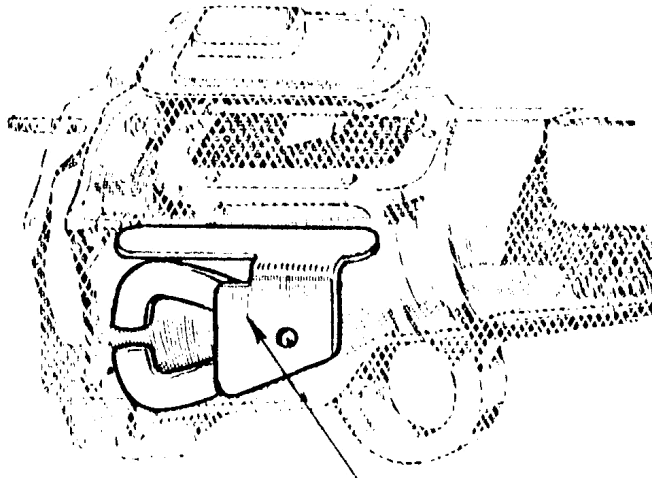
IH 3092

Complete replacement gearboxes are often fitted to remedy this trouble but such drastic measures are quite unnecessary, the fault being almost certainly due to looseness in the riveting of the interlocking arm assembly IH3092 (see sketch).

Such looseness allows the interlocking arm to ride over the selectors and rectification consists merely of replacing the interlocking arm assembly.

Should a replacement be unavailable, the existing assembly - provided it is undamaged - may be made good by re-riveting the arm to the plate. In some cases all that is required is the tightening of the existing rivet.

An indication of the correct tightness is given by the Belleville washer between the arm and the plate. This should be quite flat.
