SERVICE MEMORANDUM

16 October 1959

REMEDIES FOR POSSIBLE COMPLAINTS

'MGA' TWIN-CAM

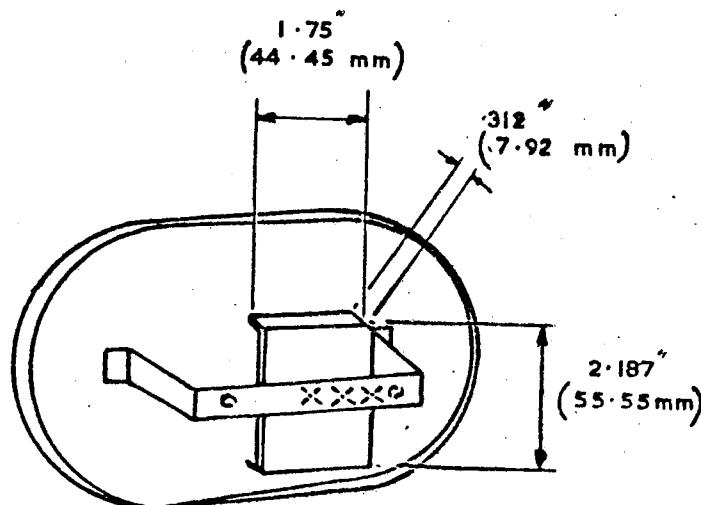
Air cleaners:

In the case of the first 28 cars it is possible for the elements in the air cleaners to move out of position and foul the carburettor inlet.

The remedy is to spot-weld a piece of .031" thick steel strip, $1\frac{3}{4}$ " long and with turned ends, to the air cleaner inner bracket, as shown in the accompanying sketch.
