MG / 296

## SERVICE MEMORANDUM

### PISTON FAILURE

'MGA' Twin-Cam

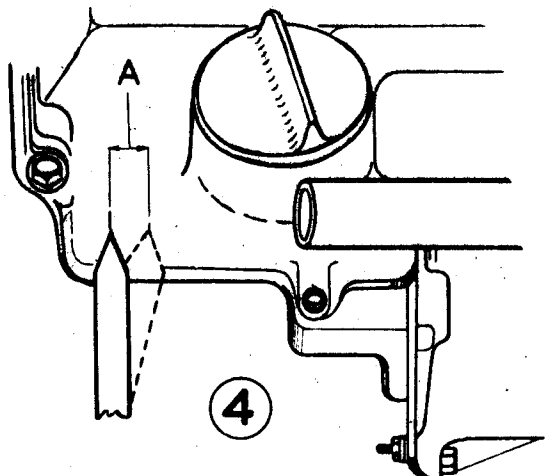
6. The pointer should now be turned so that it is over flange of camshaft cover (see Fig. 4) and then tightened on the rotor arm. The backlash in distributor drive gears is now indicated by the maximum movement of pointer. Turn pointer anti-clockwise and mark position of end of pointer on flange; then turn pointer clockwise and mark again (see 'A' Fig 4).

If distance between the two marks exceeds  $\frac{5}{16}$ " (8 mm.), distributor drive gears must be renewed before new distributor is fitted.
