Four long years

Ian Evans describes the restoration of his 1959 MGA Twin-Cam

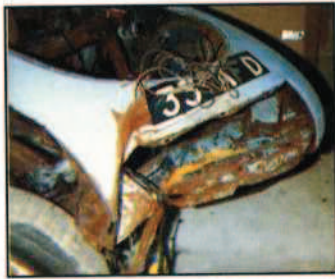
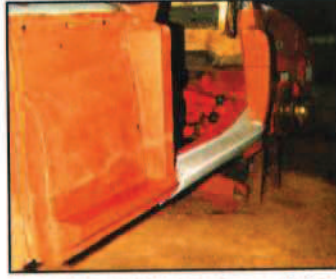
As the rebuild on the engine was progressing, so work on the rest of the car slowly began to show more positive results. With the engine and gearbox out I indulged in the luxury of having the car steam-cleaned, and having seen the result wished I'd had it done sooner. The severe crash damage to the front was the major area attended to first and once again I was fortunate in being able to rely on the help of another good friend, TR enthusiast Brian Toalster. His skill with a welding torch is legendary and once the front end began to resume its proper shape and another chassis extension had been fitted it seemed that real progress was taking place at last. The massive and complicated chassis was de-rusted, given one coat of 'Trustan' and two of 'Bonda-Primer' followed by two coats of gloss enamel. (Against all advice I chose bright red and was to so much regret the final dazzling result that a year or so later I painted the whole chassis yet again — this time in black). As I also treated all the new panels and repair sections with coats of 'Trustan' and 'Bonda-Primer', by the end of the re-build I felt I should have bought shares in those firms!

Above left, two shots of the car before work began showing the rust damage and the crash-damaged front end. Above, after restoration. Above right, the completed engine prior to testing. Far left, nsf wheelarch showing the removable access panel. Left, work on the car in progress. Note the fully repaired front which used standard MGA parts. Right, complete! The start of the first family outing. Ian Evans muses that neither daughter was born at the start of the rebuild!
