SERVICE MEMORANDUM

REAR MAIN BEARING OIL LEAKS

MAGNETTE

MGA

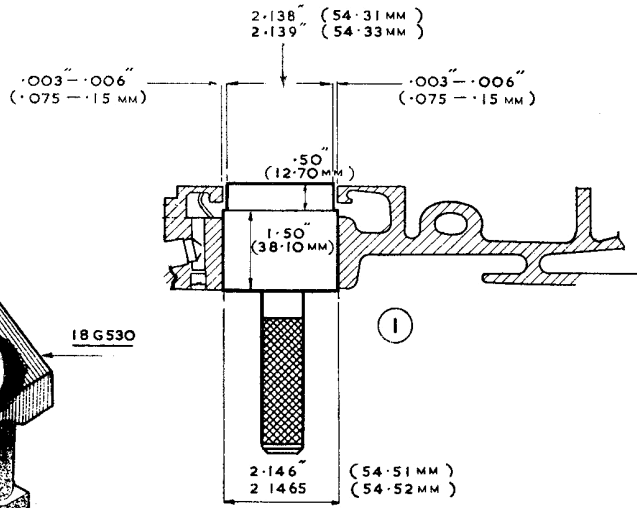
2. Additionally, the following procedure may be adopted:
 - (a) Remove drain-tube from rear main bearing cap and clamp drilling jig, Part No.18G530, to cap (Fig.2.).
 - (b) Set this assembly up on a drilling machine and drill the two $\frac{5}{8}$ " (15.87 mm.) holes shown. Care should be taken to drill only as far as the oil gallery.
 - (c) Remove jig from cap and file slot in cap in dimensions shown in Fig.3.

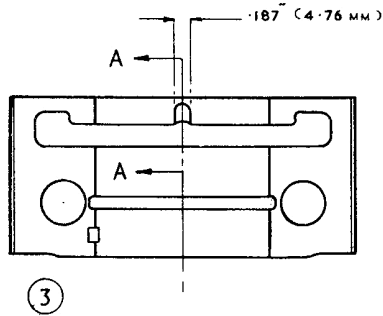
N.B. These dimensions should not be exceeded.
