NISONGER INSTRUMENTS

Important Information

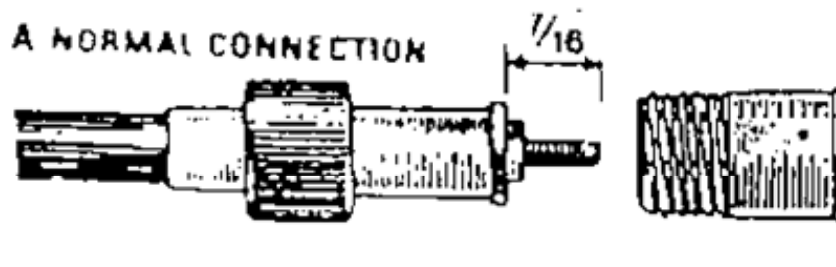
Please refer to the drawing below for the correct inner cable dimension. Before checking the dimension, be certain that the inner cable is fully seated into the outer cable/housing.

When re-installing the instrument, check to be certain that the inner cable is fully seated into the receiver/drive assembly at the back of the speedometer or tachometer and that (with the cable affixing nut slid back on the outer cable), without exerting any pressure on the cable housing, the end of the outer cable housing sits flush against the threaded post that the cable was inserted into. If there is any gap between the end of the cable housing and the threaded post, either:

- The inner cable is too long.
- A piece of broken cable is jammed into the drive socket at the rear of the unit.

If you are re-installing a Nisonger rebuild, there will not be any broken cable remnants in the drive assembly; and you should assume that the inner cable is too long. If the inner drive cable is too long, it will exert pressure on and quickly/permanently damage the internal cradle assembly.
