Four long years

Ian Evans describes the restoration of his 1959 MGA Twin-Cam

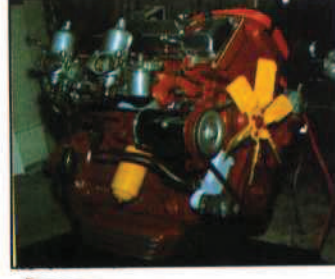
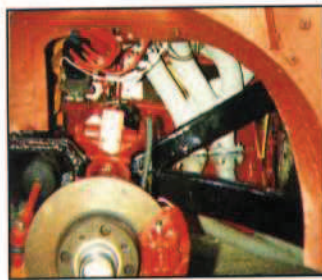
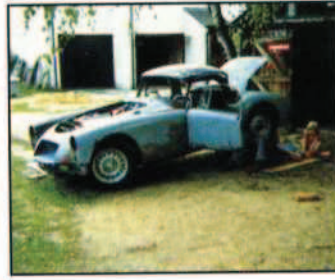
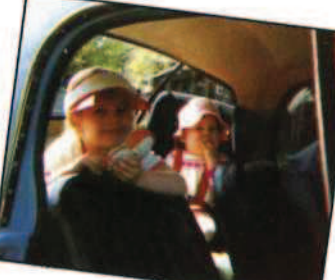
Above left, two shots of the car before work began showing the rust damage and the crash-damaged front end. Above, after restoration. Above right, the completed engine prior to testing. Far left, nsf wheelarch showing the removable access panel. Left, work on the car in progress. Note the fully repaired front which used standard MGA parts. Right, complete! The start of the first family outing. Ian Evans muses that neither daughter was born at the start of the rebuild!
