HINTS FROM AUSTIN'S MORRIS GARAGE ©

Hi, everybody. This time we're covering the maintenance and repair of the Lucas Windtone horn. This horn is installed on the late MG TC, TDs, TFs, MGAs, and many other British cars. It has also been very seldom discussed.

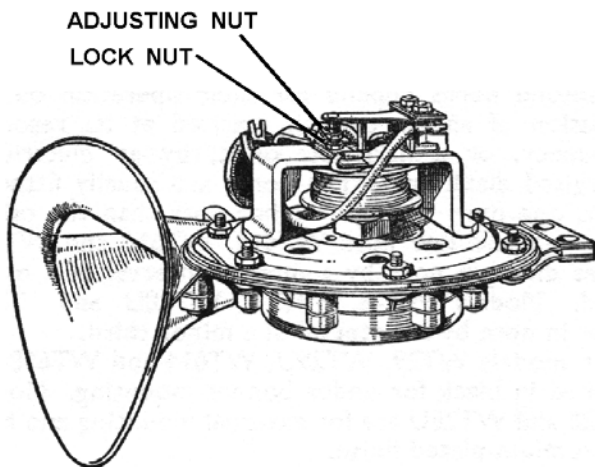
Figure 1. WT614 Horn, with Cover Removed

The horns are usually installed in pairs, one horn having a higher note than the other. The high- and low-note WT614 (early Bentley/Rolls Royce) and WT618 (most other models, including MGs from the late TCs through the Magnette Mark IV but not the MGBs or MGCs) differ in note by a major third (A to C on the piano, for instance). There are extra-loud 12-volt Windtone horns (WT28/WT29) that we will not discuss here, because of their rare use. The horn shape determines the horn model (see Figures 1 and 2). High- and low-note horns may be distinguished by the letters "H" and "L" marked inside the trumpet flares. The horns use sprung mounting brackets.

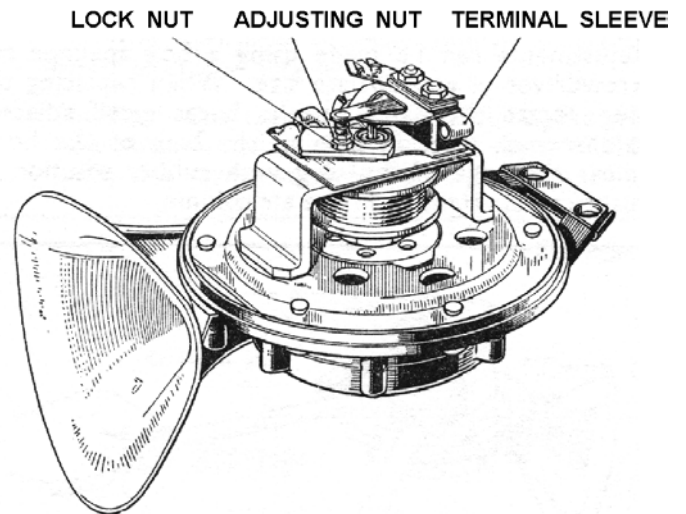
Figure 2. WT618 Horn, with Cover Removed

Note that earlier models have the base plate attached to the horn body with screws and nuts.

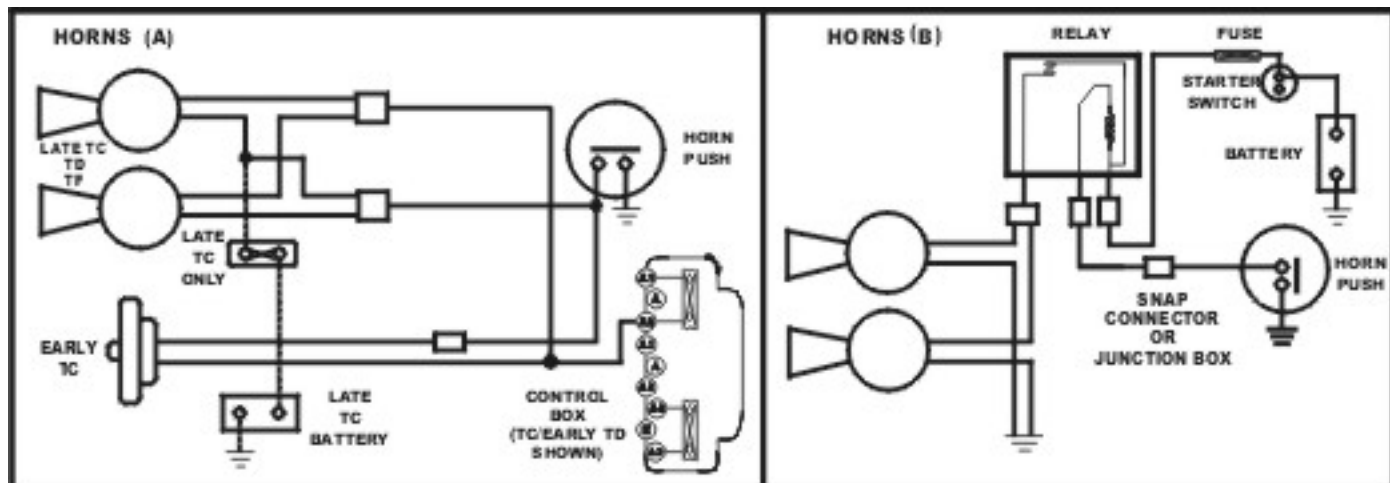
Figure 3. Typical Horn Circuit Wiring

Horns on the MG cars are generally connected directly to a 12-volt source, thus are "hot" all the time (see schematic HORNS (A) in Figure 3).

On other cars, a relay is used to minimize the current carried by the horn contacts and to reduce the voltage drop in the horn wiring (see schematic HORNS (B) in Figure 3). If desired, the direct-connected horns may be wired this way, too.

When equipped so, check the relay by connecting terminals C1 and C2 (H and B on some relays) with a short piece of heavy-gauge cable. If the horns operate properly, remove the cable and connect it between the remaining relay terminal W (or P) and ground. Persistence of the fault means there is an internal defect in the relay, which will have to be replaced. If the horn does sound, check the horn push circuit.

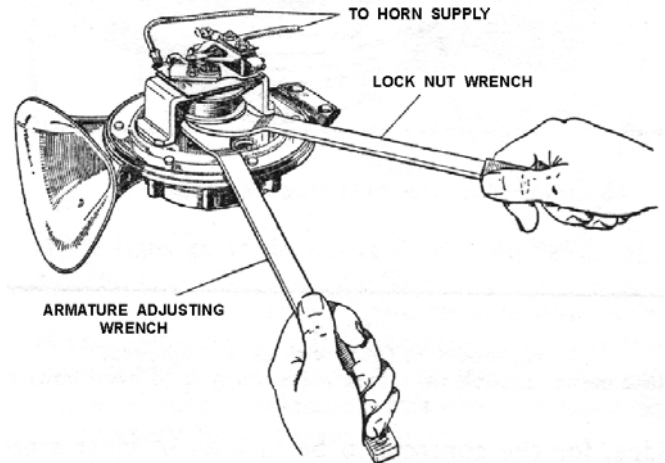
Figure 6. Adjusting the Armature

1. Slacken the armature lock nut.
2. Reset the armature, using the tools, as in Figure 6.

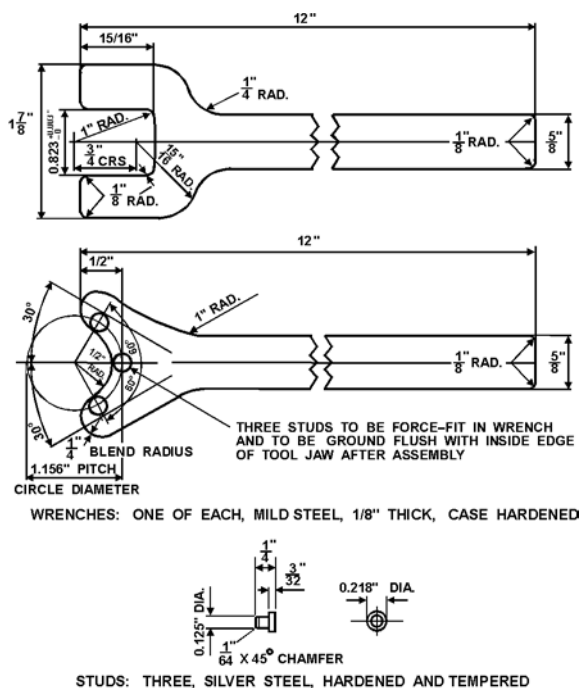
Figure 5. Adjusting Tool Dimensional Drawings

Figure 5 shows two special tools required for making armature adjustments on WT614 (top) and WT618 horns.

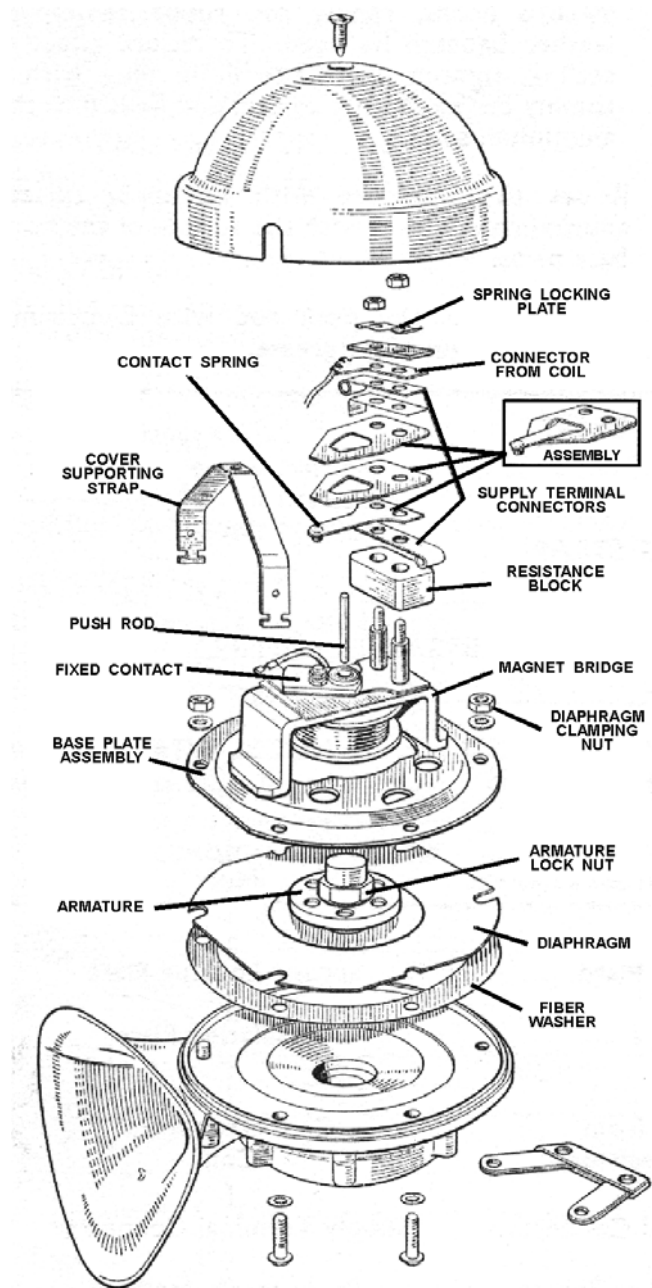
Figure 7. WT618 Shown Disassembled

Unless a major fault occurs, such as a broken diaphragm or a burned out coil (both of which are very rare faults), dismantling of the movement itself is not advisable. If however, dismantling is necessary, refer to Figure 7, and follow the order of disassembly in Figure 8. When a horn coil housing and base plate is affixed to the die cast body with rivets, the rivets must be drilled out. To reassemble, reverse the order in Figure 8. Upon reassembly, the holes must be drilled out to 7/32 in., and the rivets replaced by appropriate machine screws and nuts.

7. The terminal block assembly nuts on WT618 horns must be tightened to a torque of 30 in. lb, to obtain consistent horn performance.
8. Carry out an insulation test before connecting power to the horn. Test between each terminal and the horn body with a 500 volt insulation tester.

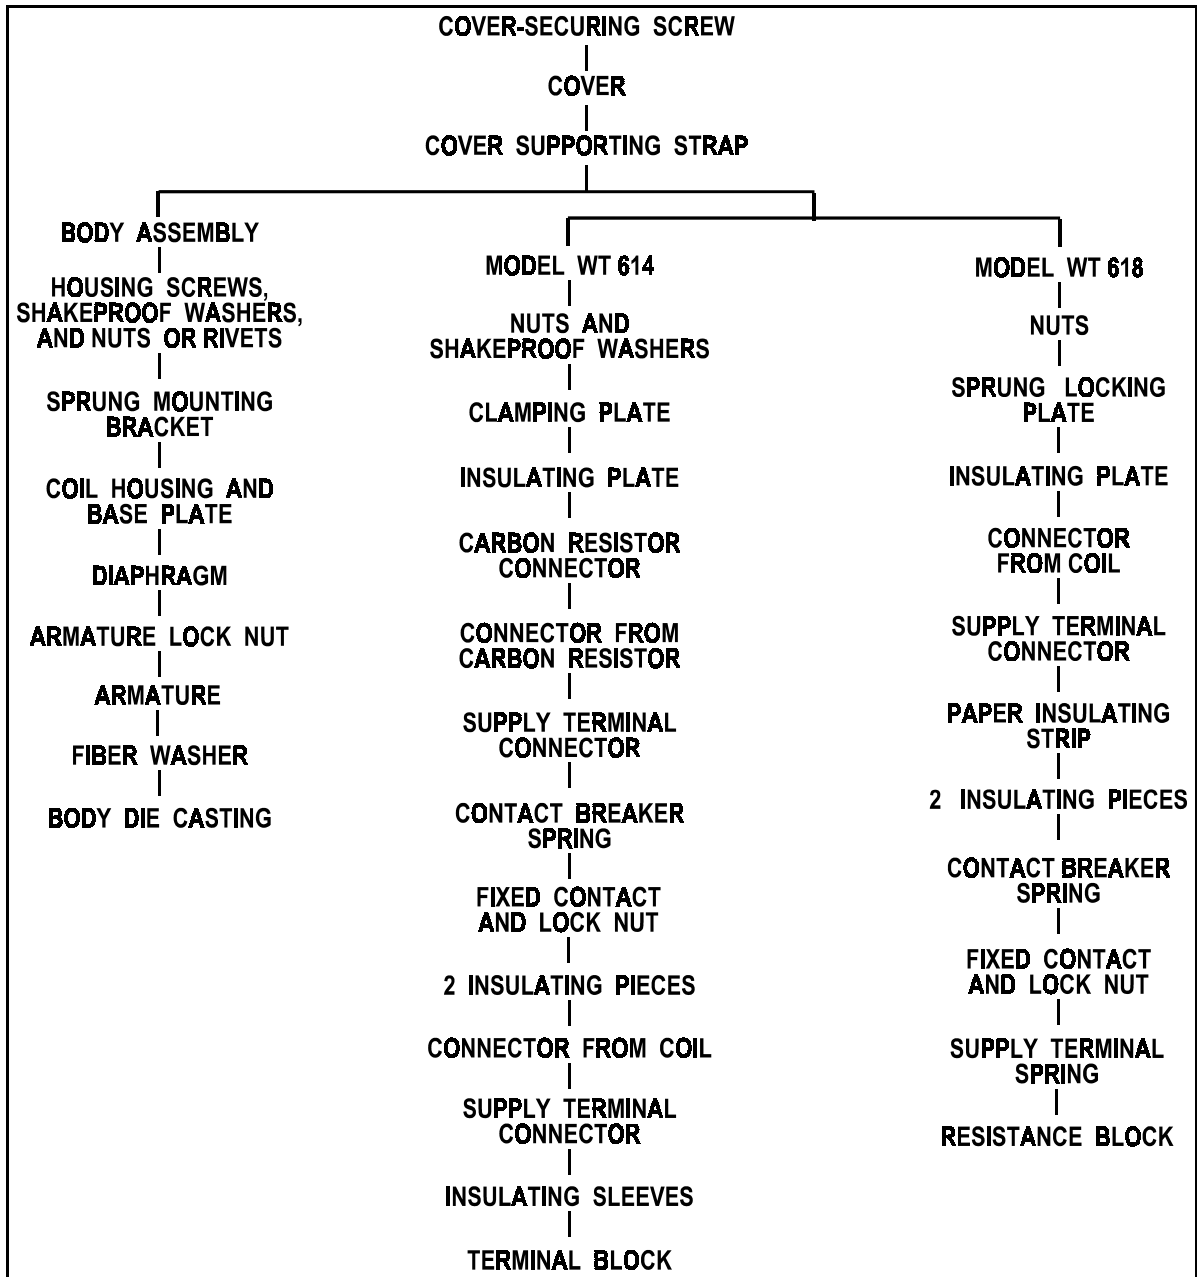
Figure 8. *Dismantling and Reassembly Sequence*

Reassembly is done by reversing the dismantling sequence, and the following points must be observed when the horn is being reassembled:
